# Manhole Inspection Summary

Manhole # S33S\_\_015MH

Insp Date: **2/5/08 3:43 PM**

**Location** Address: **race st**

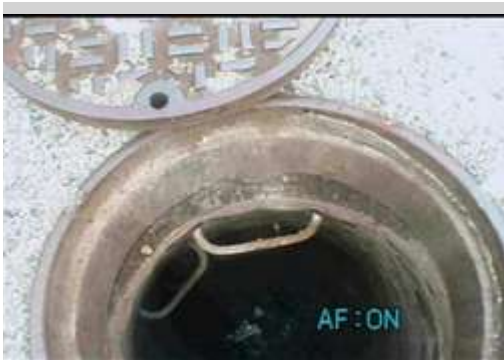
Defect 3

Offset: **1** (in.)

Count: **6** Missing: **0** ☒ **Corroded**

offset and corroded steps

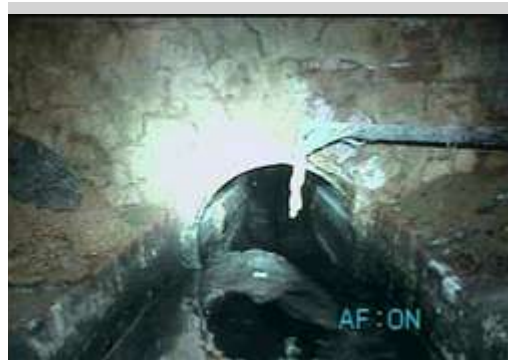
Defect 2

Condition: ☐ Sound ☐ Cracked ☐ Root Intrusion ☐ Deteriorated ☐ Leaks ☒ **Debris**

channel debris

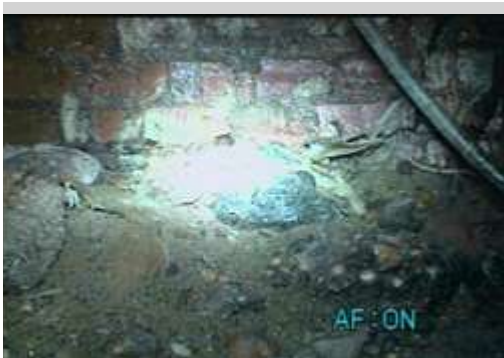
Defect 1

Condition: ☐ Sound ☐ Cracked ☐ Root Intrusion ☐ Deteriorated ☐ Leaks ☒ **Debris**

bench debris
